RESIDENTIAL STYLES GUIDE

Dated: November 18, 2011

Adopted by Town Board: December 7, 2011

Residential Styles Guide

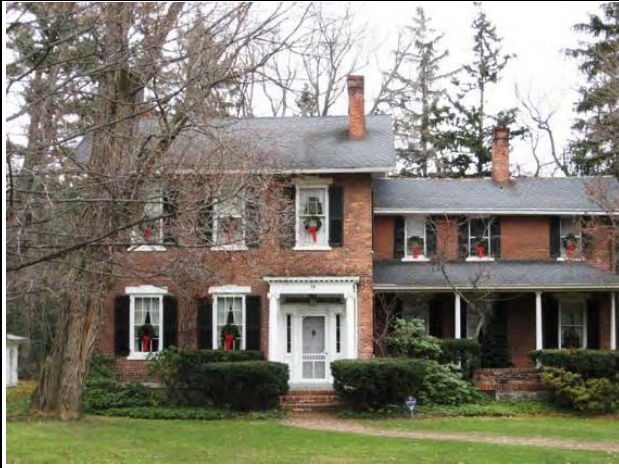
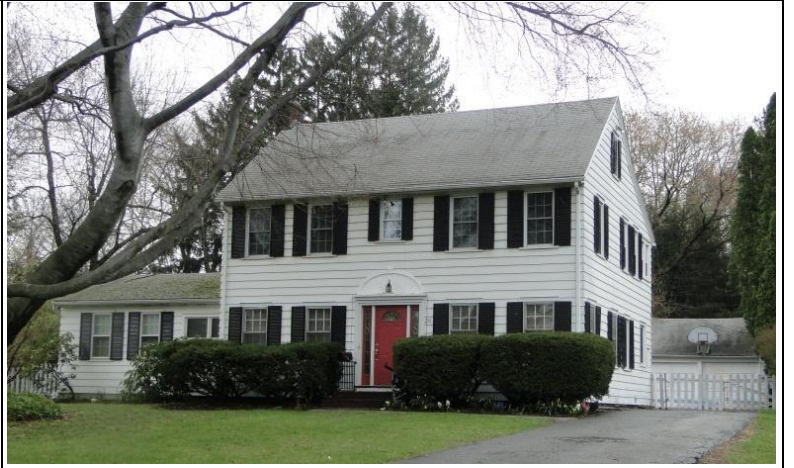
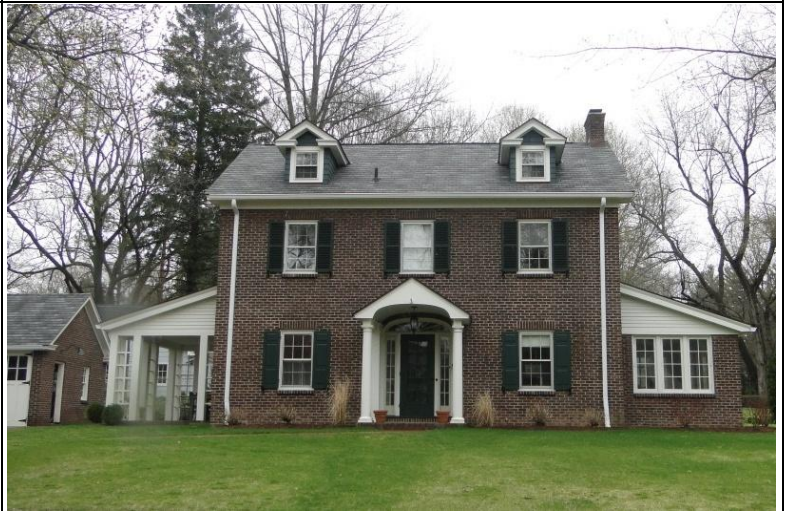
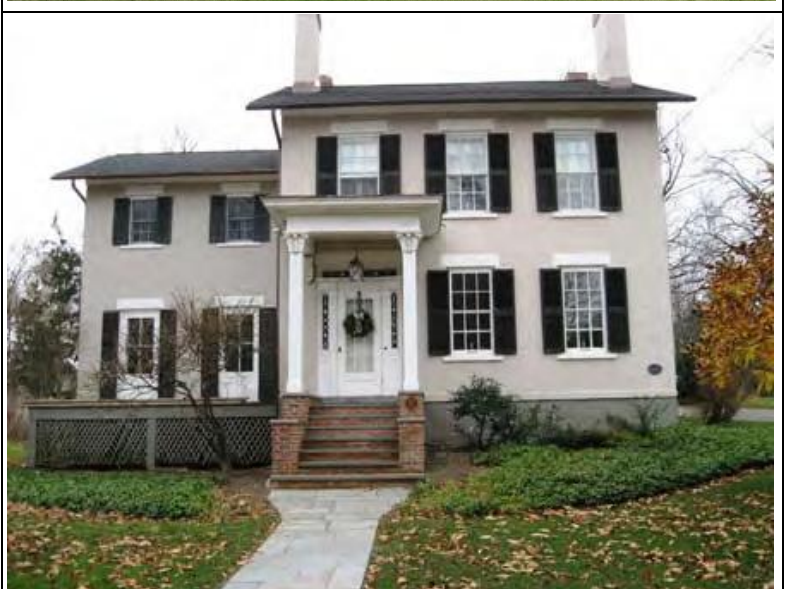
Federal

Design: Three-bay facade with side entrance on most homes. Five-bay symmetrical center entrance on larger houses. Usually symmetrical facade layout.

Roof: Moderate roof slope with cornice returns, full pediment gable, or stepped gable.

Porch: Typically a single bay porch at the entrance, supported by slender Tuscan columns.

Windows: Double-hung with 12-over-12 or 6-over-6 sash, uniform size and regular, symmetrical spacing.

Doors: Six-panel doors with sidelights and rounded fanlight transom window above. Simpler homes may have a projecting transom cornice over the door.

Details: Elliptical and semi-elliptical fanlights on gable ends. Multiple chimneys near gable ends or one central chimney.

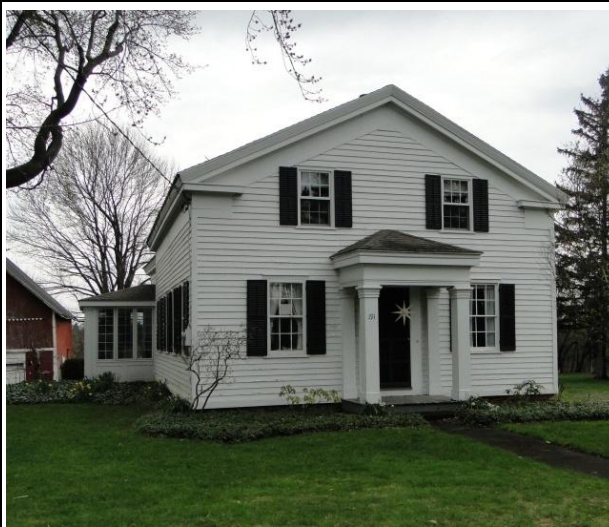
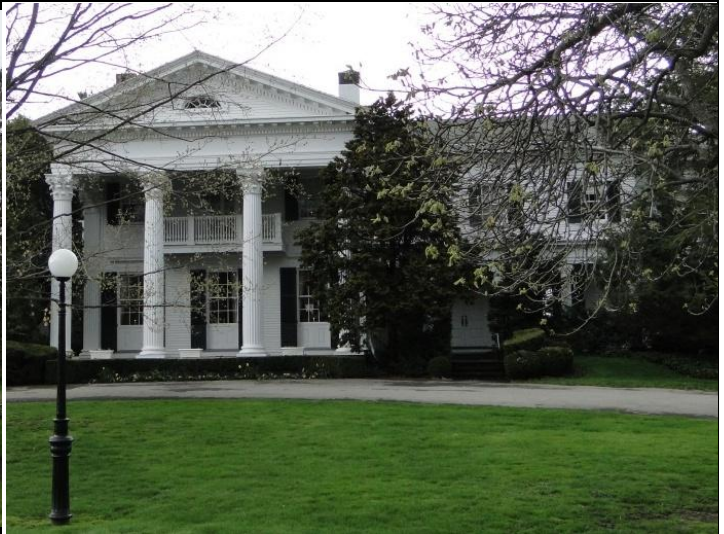
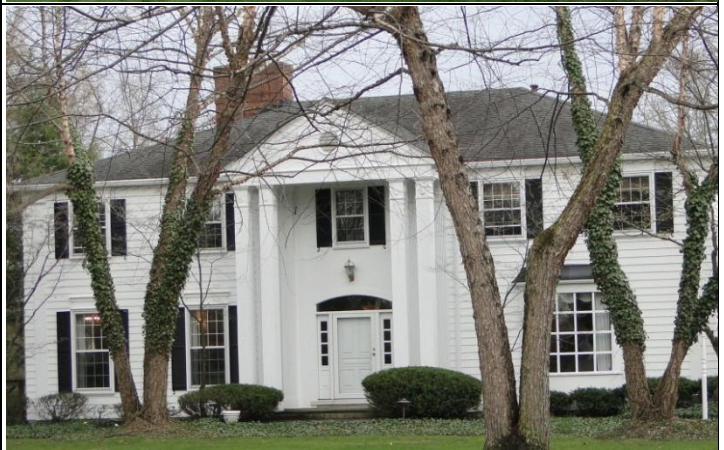
Greek Revival

Design: 3 bay facade with side entrance or center entrance, or 5 bay symmetrical center entrance.

Roof: Moderate slope with cornice returns, or full pediment gable. Front gable, side gable or hip roof.

Doors: One or two-panel doors with sidelights and transom windows. Often framed by formal pilasters.

Details: Square porch columns with Doric capitals. Porches are more common than on Federal style. Occasional use of corner pilasters can be distinguished from federal style by wider dimensions of pilasters, columns and frieze trim.

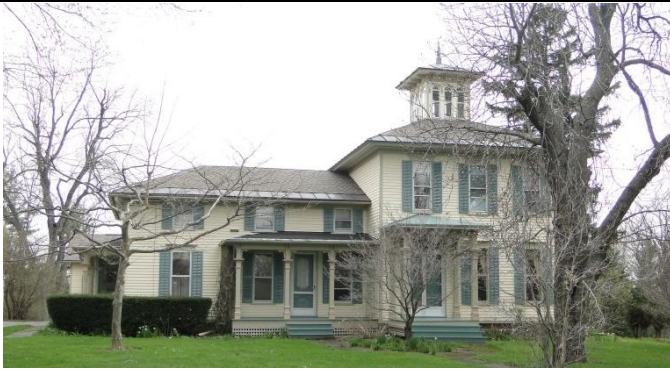
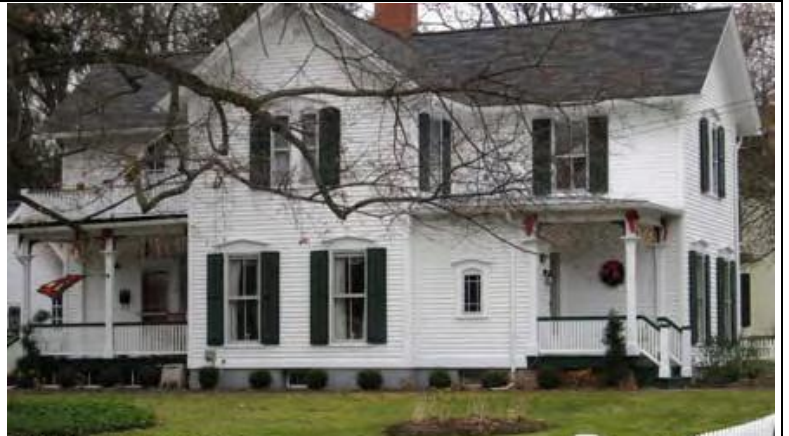
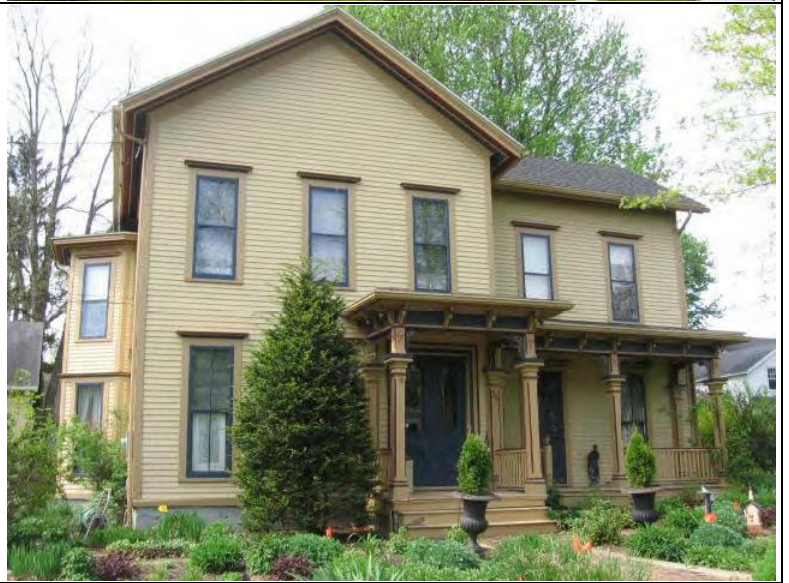
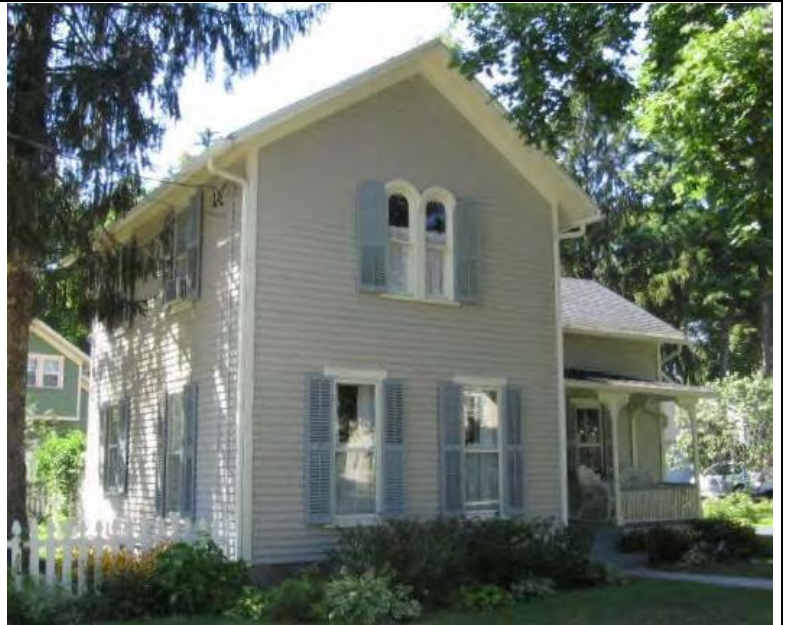
Italianate

Design: Front gable 3-bay with side entrance, gable and wing.

Roof: Moderate slope with large overhangs, overhanging eaves, often with decorative brackets. Hip roof examples have a very low slope, and sometimes have Belvedere.

Porch: Typically a single bay porch at the entrance. Full width or wraparound porches also common. Columns are often square with chamfered edges, capitals and scroll brackets.

Windows: Double-hung 6-over-6, 2-over-2 or 1-over-1 sash. Windows typically tall and narrow. Double half round windows often found on gable ends of upper floors. Floor-to-ceiling windows common on first floor. Bay windows.

Doors: Double-leaf doors often tall and narrow, with $\frac{3}{4}$ length glass panels.

Details: Trim and often incorporate bold "rolled" profile moldings.

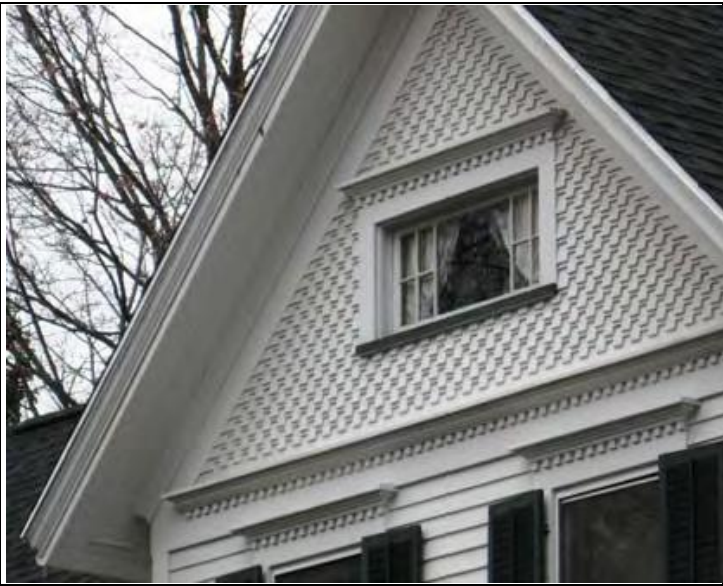
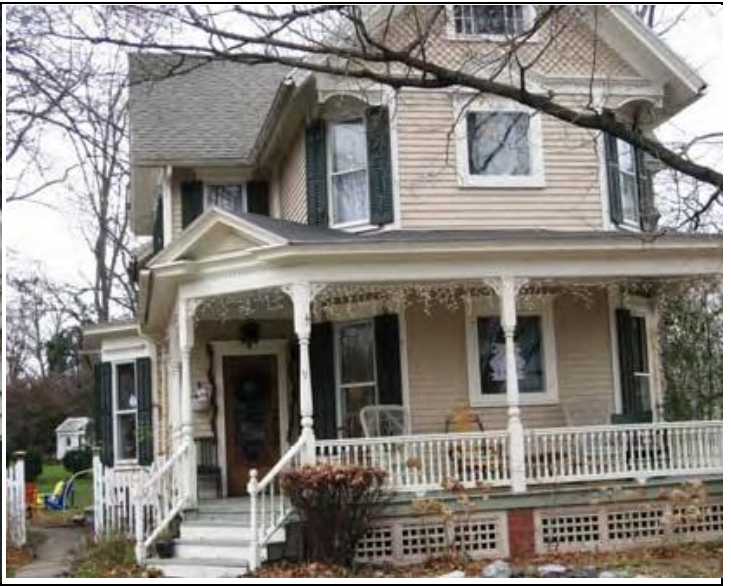
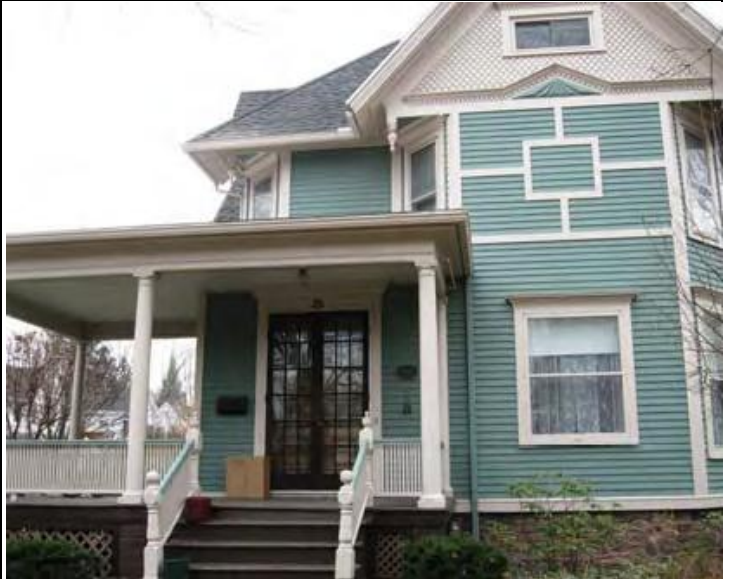
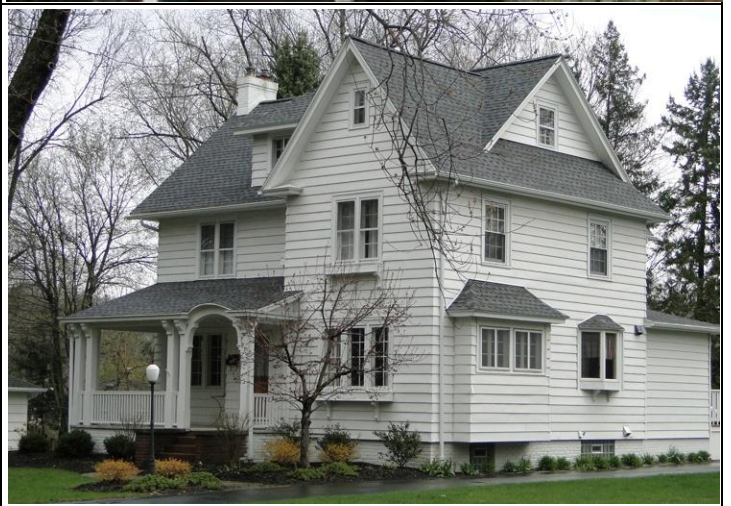
Queen Anne

Design: Symmetrical cross-gable or asymmetrical layout, sometimes with combination of gable and hip roof forms.

Roof: Steep slope, often complex shapes.

Porch: Often wrap-around corner porches with round turned posts, sometimes scroll brackets. Decorative spindle-frieze common along top of porch.

Windows: Double-hung with 6-over-1 or 1-over-1 sash. Varied window widths ranging from tall and narrow, to wide even on same structure. Detailed molded hoods over windows are common.

Details: Special detailing at top of gable is often found, such as a transition from wood clapboard to shingles. Upper gable is often separated from facade below by horizontal break or belt course.

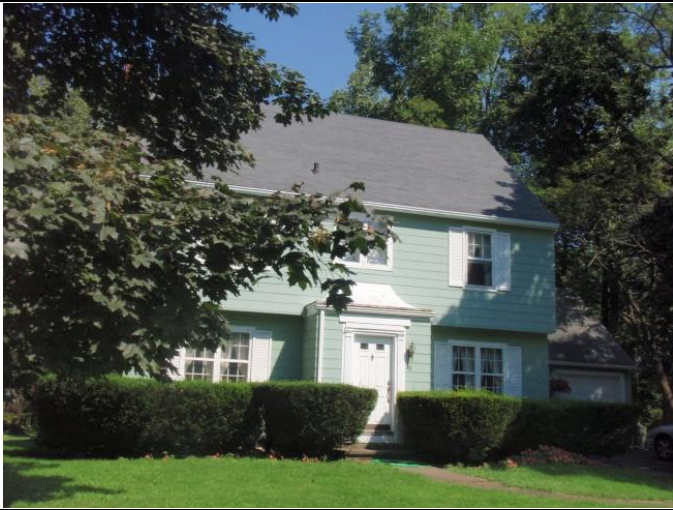
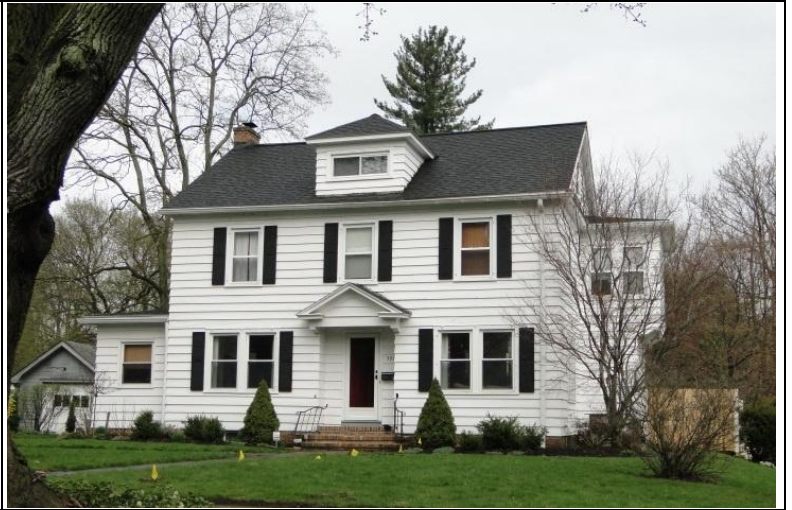
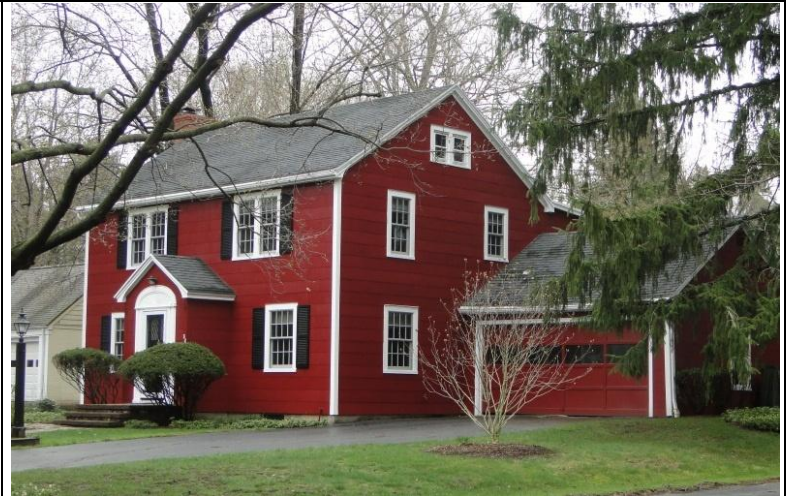
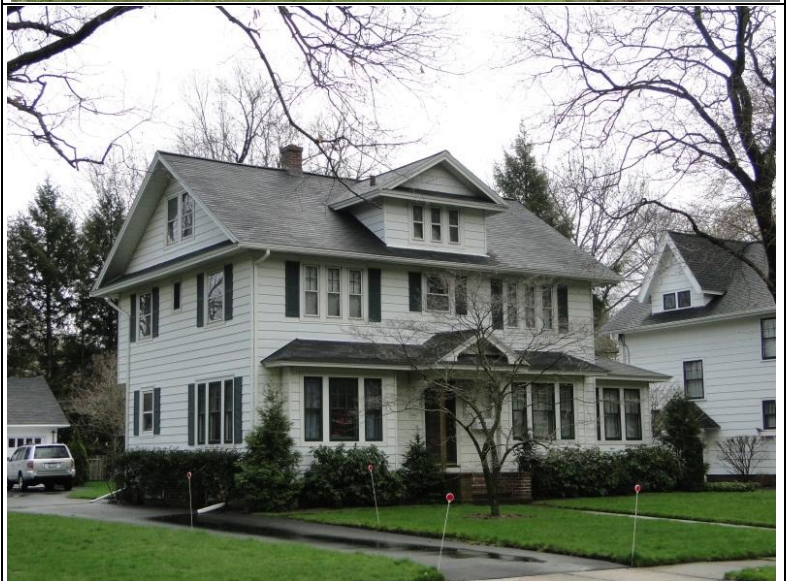
Colonial Revival

Design: Symmetrical 3 or 5-bay facade with center entrance.

Roof: Moderate pitch with cornice returns or full gable pediment, dormers. Typically side gable. Gambrel and hip roofs also found.

Porch: Single bay porch at entry with Tuscan columns or bracket supported canopy.

Windows: Double-hung 6-over-6 or 6-over-1 sash, often with shutters. Uniform size and regular spacing. Bay windows common.

Details: Gable-end lunette, exterior chimneys.

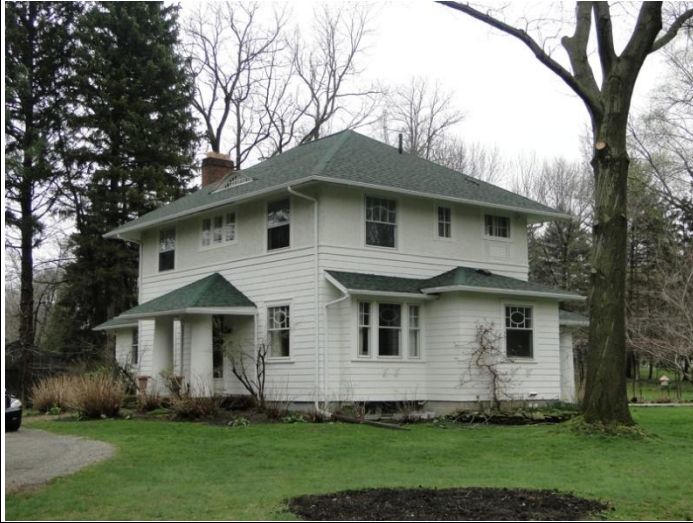
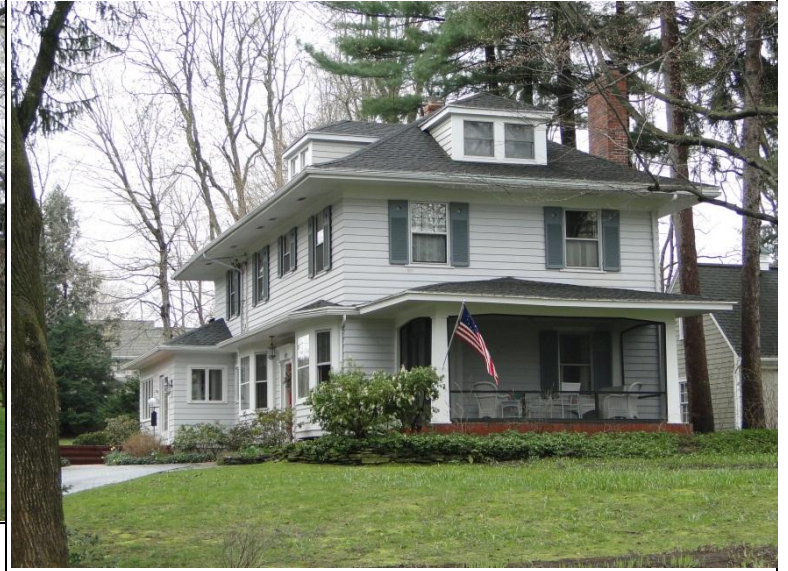
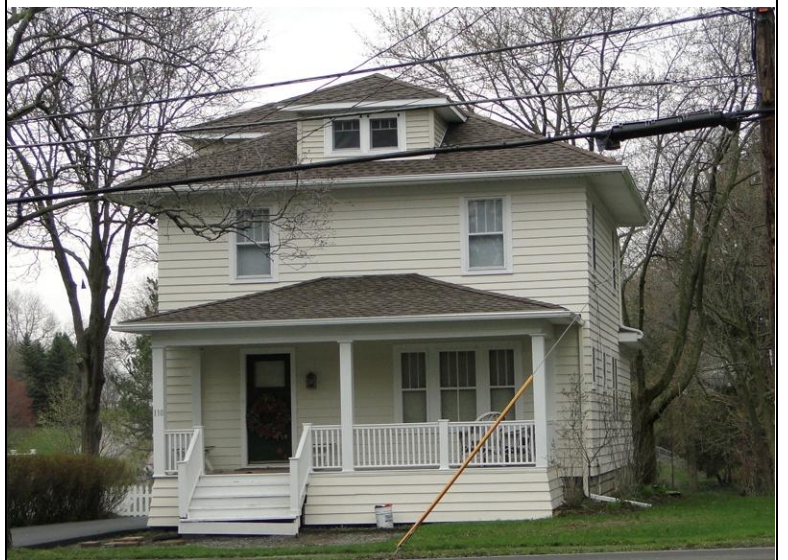
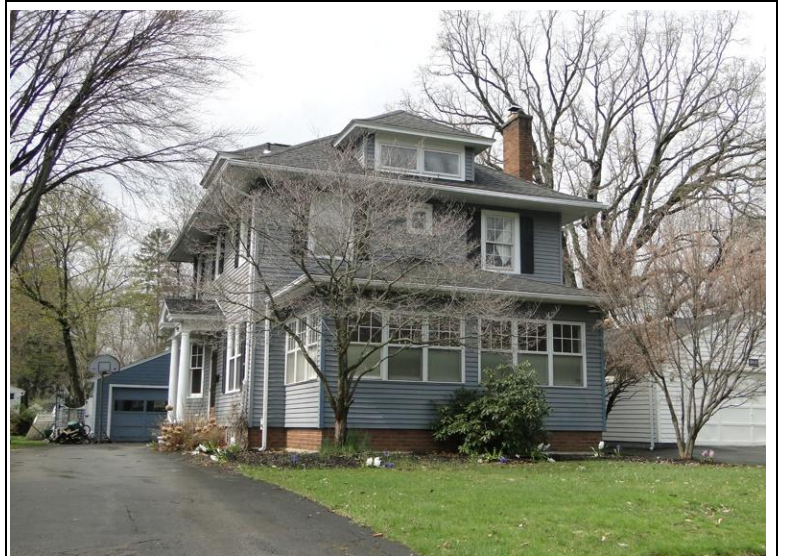
Foursquare

Design: Square or rectangular in footprint, facade often 2 bays wide.

Roof: Steep slope 12:12 pitch gable or hip roof, typically with dormers.

Porch: Typically 2-bay porch covers width of house. Square porch columns or 3/4 height posts set on masonry piers.

Details: Upper floors or gable is often separated from facade below by horizontal break or belt course, with change in materials or colors.

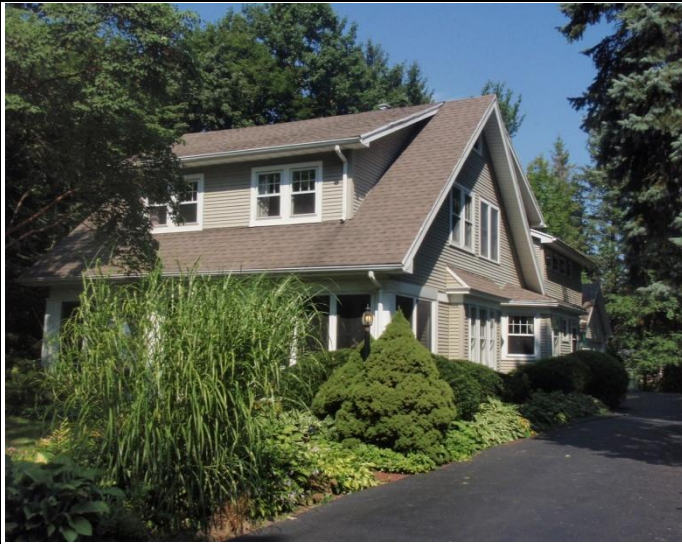
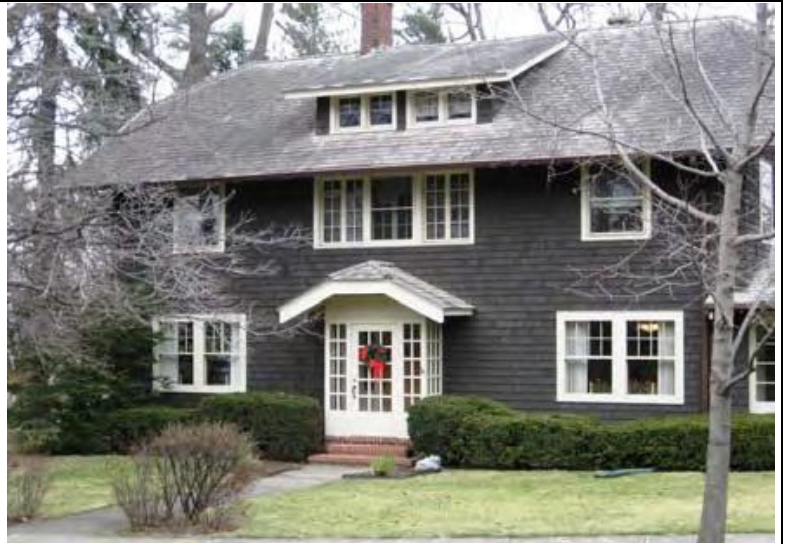
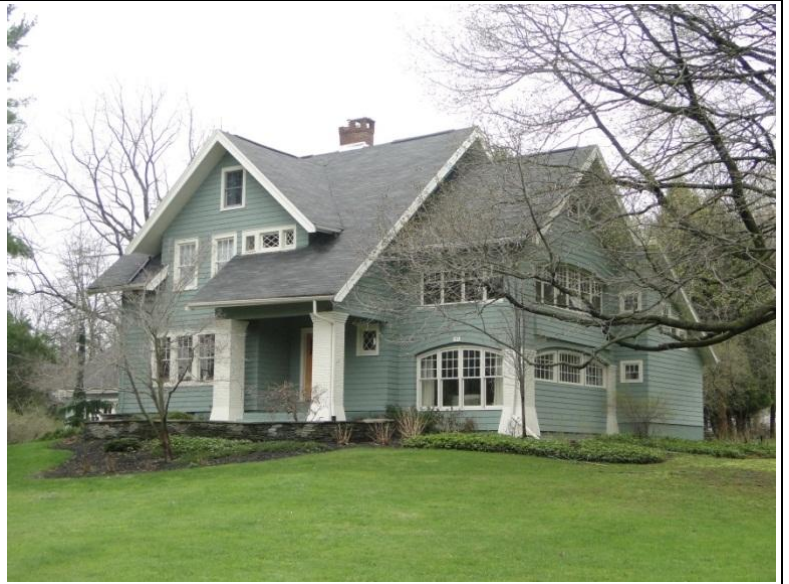
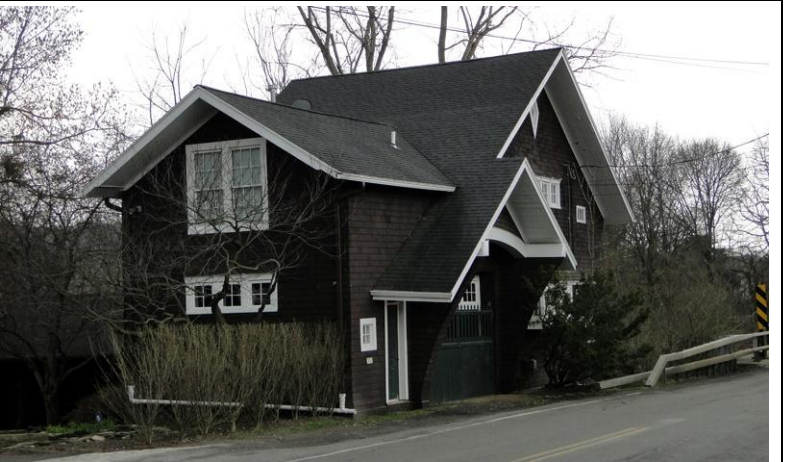
Craftsman

Design: Commonly side gable, square or rectangular in footprint. Some front gables.

Roof: Moderate slope and pronounced roof. Porch roof is often an extension of primary roof above. Often large shed gable or hip dormer in center of roof. Deep roof overhangs, sometimes with support brackets. Exposed rafter tails.

Porch: Porches are typically full width of facade when present. Porch posts typically are stout square posts set on masonry piers.

Windows: Double-hung with 6-over-6 or 6-over-1 sash, often paired. Some casement windows. Windows vary in size and placement.

Details: Sturdy, simplified appearance with rustic look. Not much ornamentation.

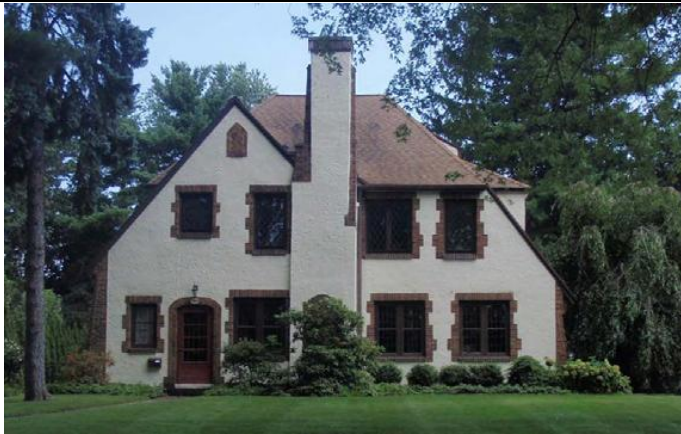
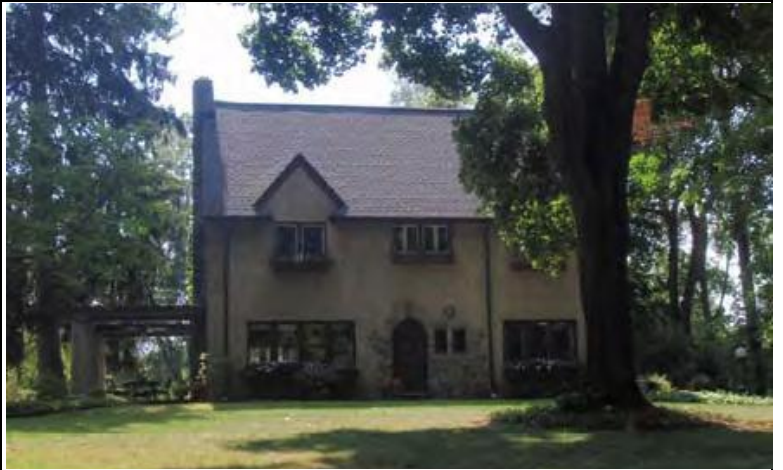
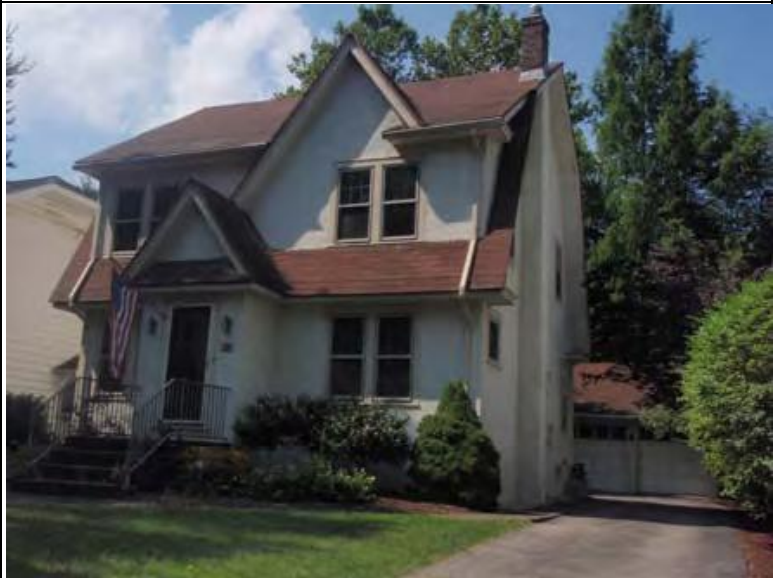
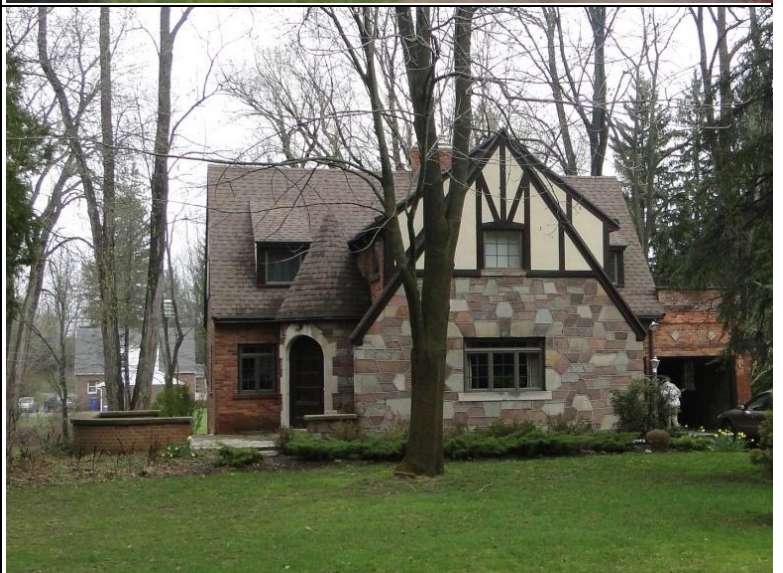
Tudor Revival

Design: Asymmetrical layout, often with small gable over entry.

Materials: Stucco, stone, brick or wood shingles, often with a mixture of materials on the same structure.

Roof: Steep slope with little or no overhangs, complex roof forms with multiple gables, shed dormers. Slate roofs are common.

Porch: Small entrance porch, if present, or side porch. Posts and brackets detailed to resemble heavy timber construction.

Windows: Often wide casement windows, paired in 2's or 3's, often with leaden sash.

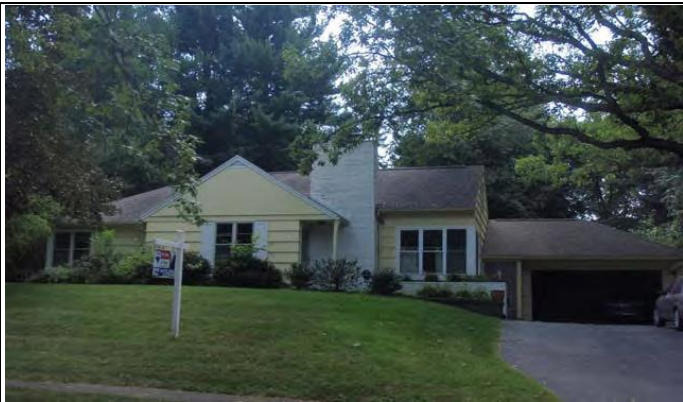
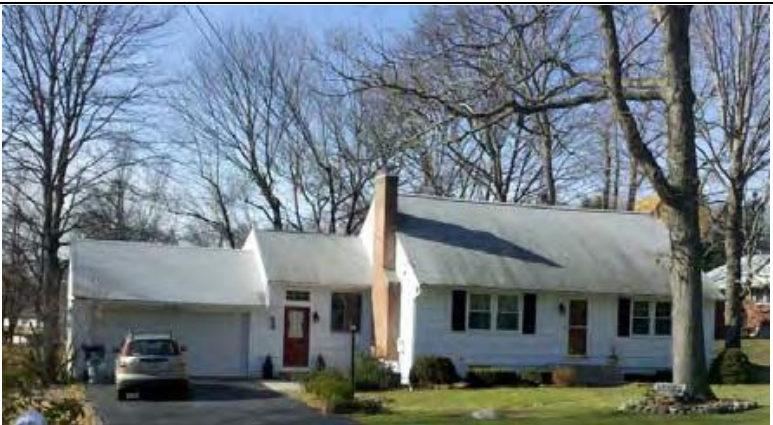
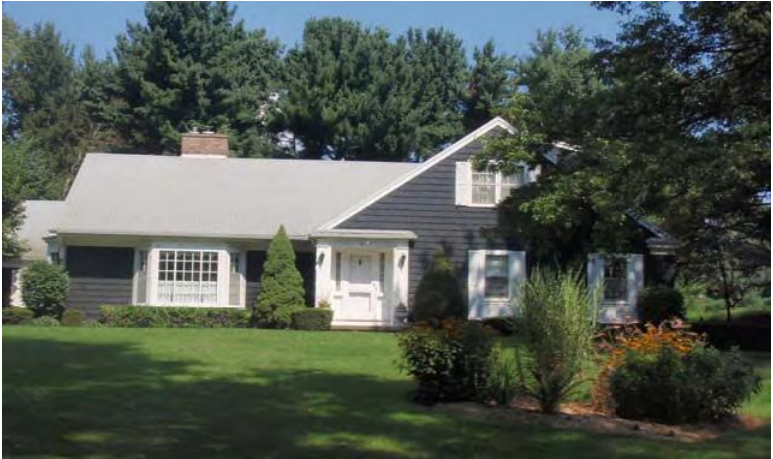
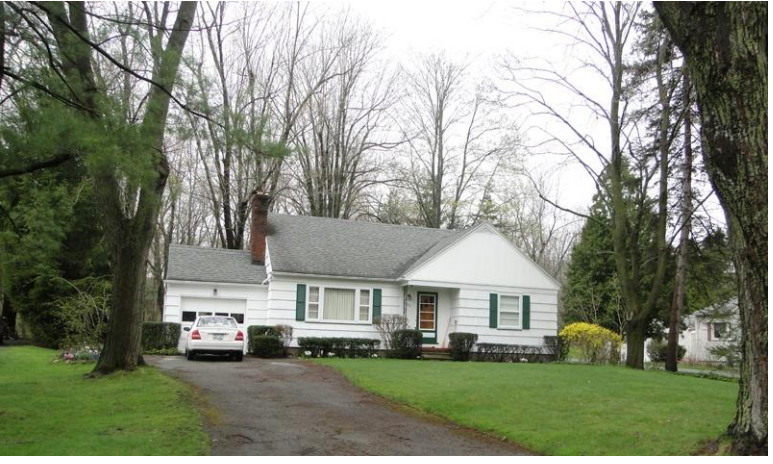
Minimal Traditional

Design: Asymmetrical, with main roofline often parallel to road and gable.

Materials: Wood clapboard, brick, stone, often in a mix.

Roof: Low to intermediate roof pitch. Minimal eave overhangs, minimal or no rake overhangs.

Details: Typically has one wide chimney.

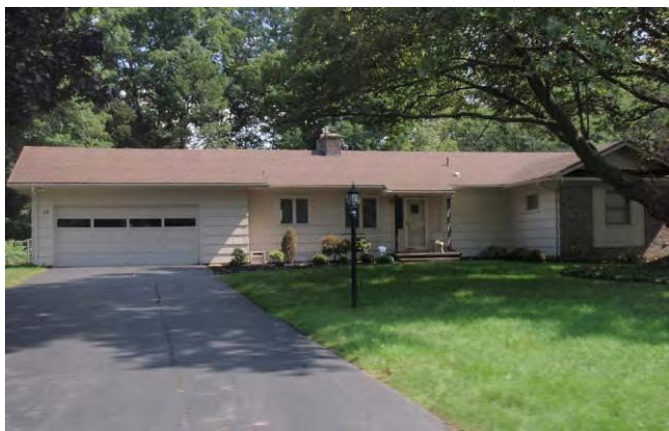
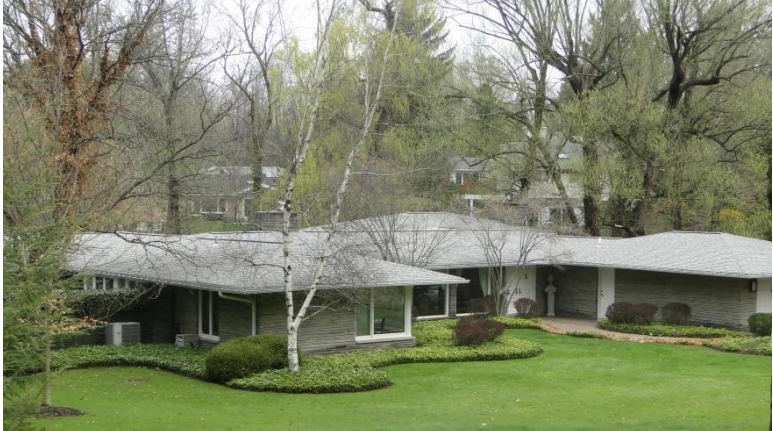
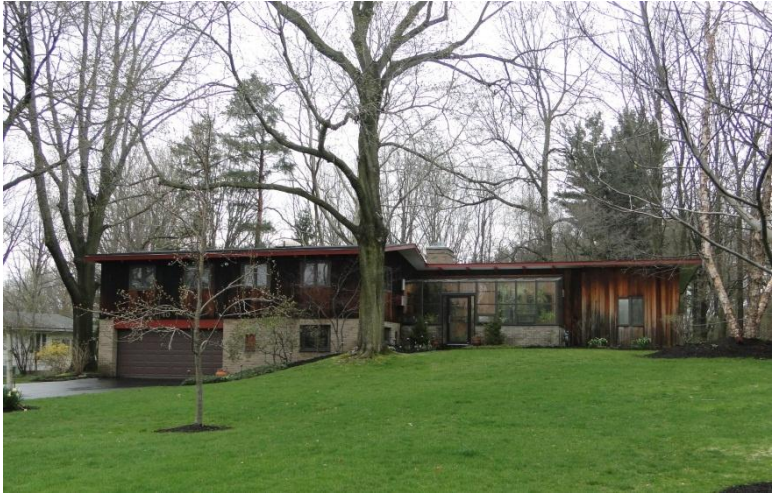
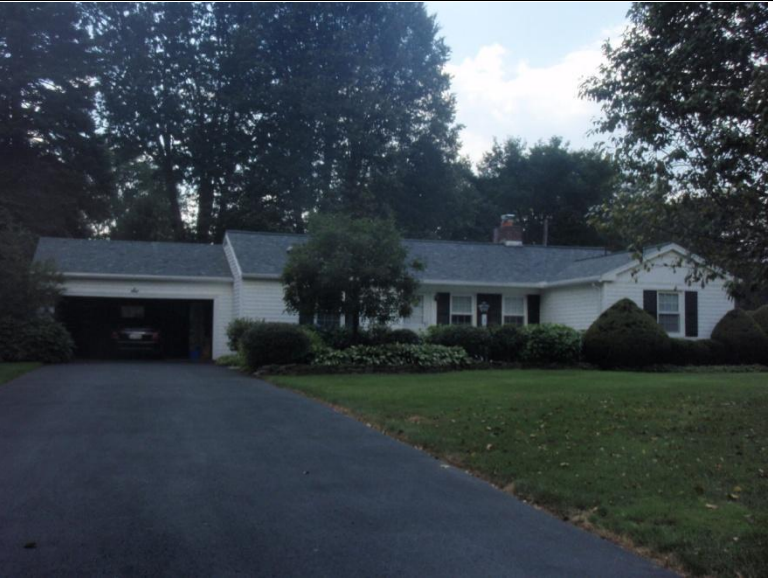
Ranch

Design: Long asymmetrical layout, often with garage at one end. Sometimes small gable over entry. Maximizes facade width along road.

Roof: Very low slope with medium to wide overhangs. Main roofline typically runs parallel to street. Hipped, cross-gabled and side-gabled. Asphalt shingles most common.

Porch: Small entrance porch area sometimes found, often with roof which is an extension of main roof above.

Windows: Often wide picture or casement windows, or sometimes double-hung with shutters.

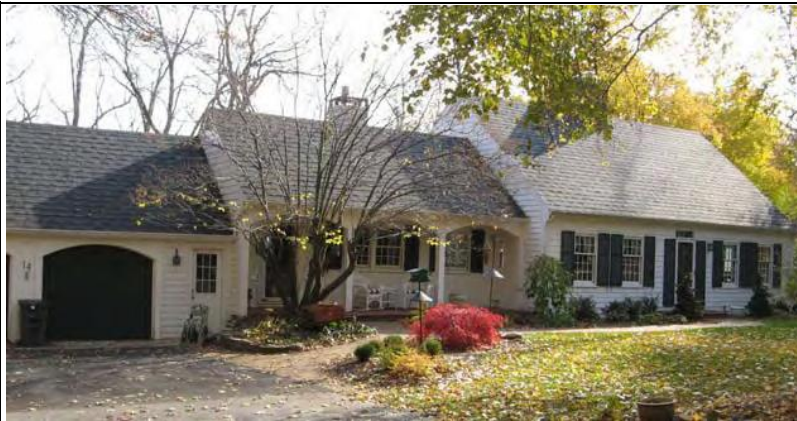
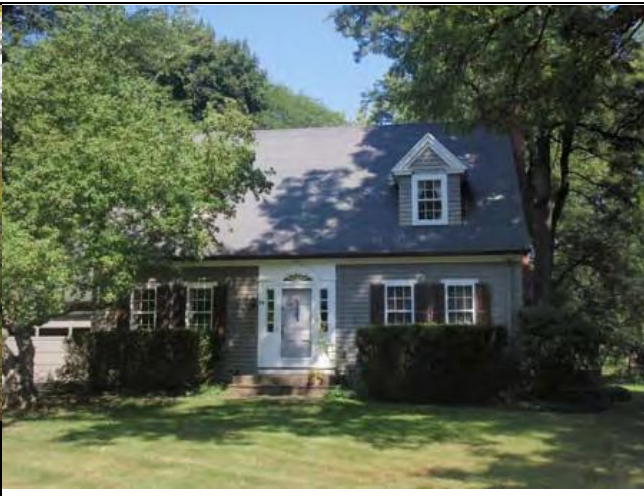
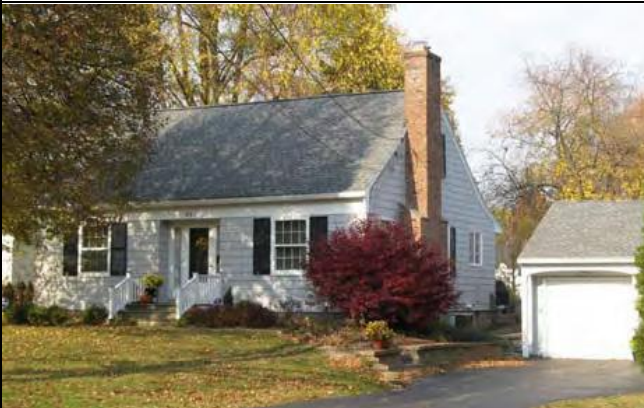
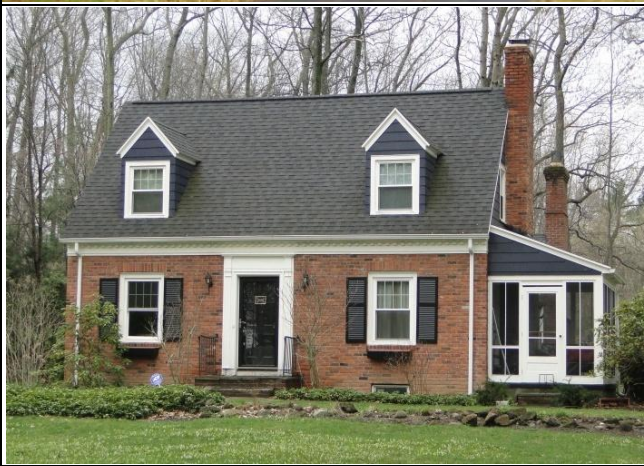
Cape Cod

Design: Ridgeline parallel to road, symmetrical center entrance common.

Roof: Steep gabled roof, ridgeline parallel to street, with a small overhang and dormers.

Windows: Relatively tall with small panes, usually double hung.

Garage: Detached, or attached with a breezeway and clearly subordinate to the main house form; earlier examples were built without garages.

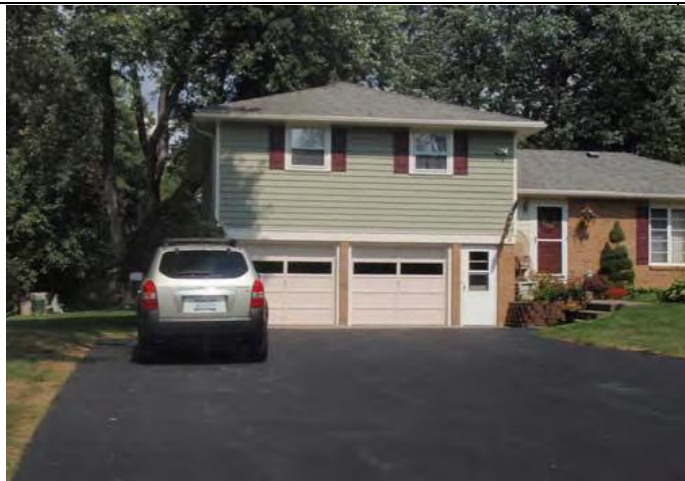
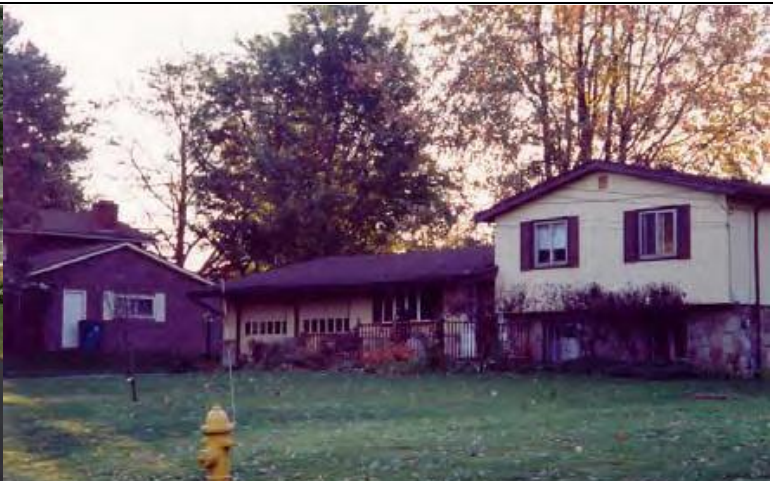
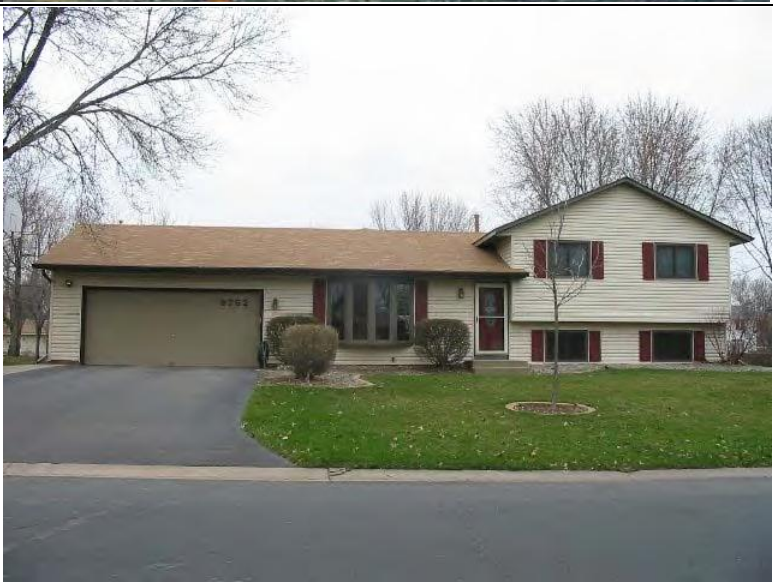
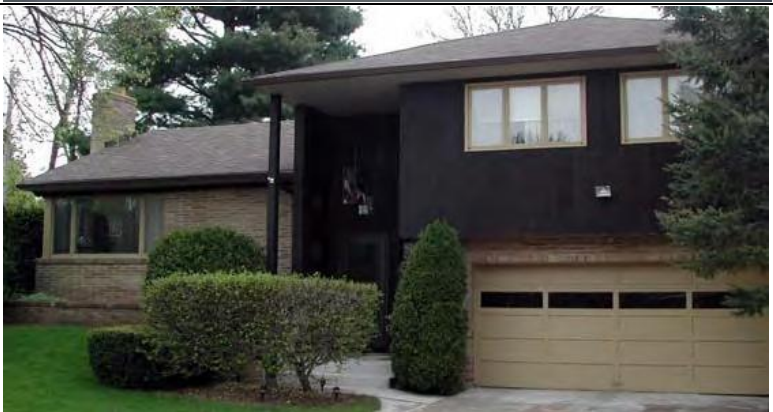
Split Level

Design: Asymmetrical layout, with garage at one end often underneath second story. Two-story section of home is intersected at mid-height with single-story area on one side.

Materials: Wood clapboard, vertical wood siding, stone and/or brick, often mixed together.

Roof: Low to moderate roof slope with medium to wide overhangs. Hipped and side-gabled roof shapes. Asphalt shingles most common.

Details: Often utilizes mixture of different materials and colors along facade.

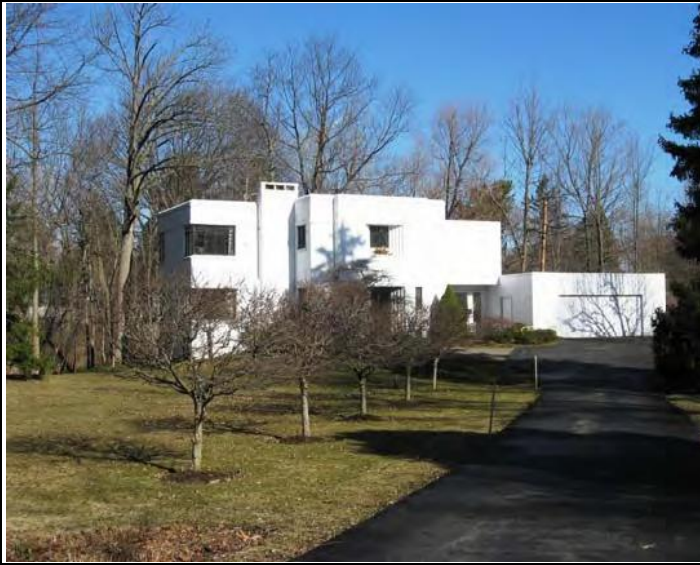
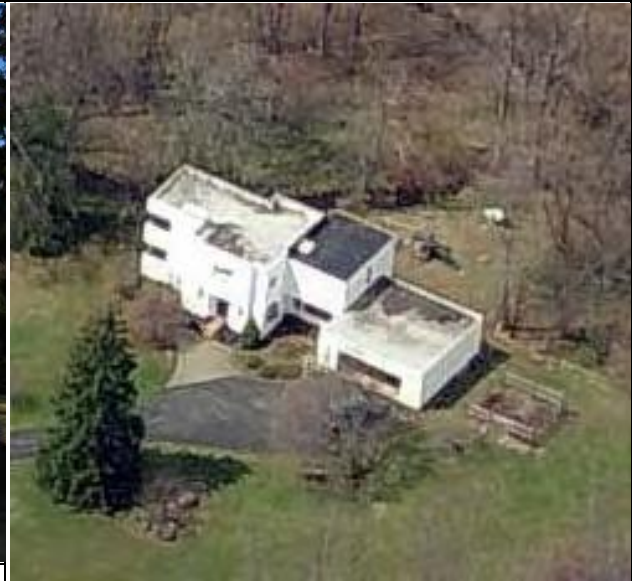
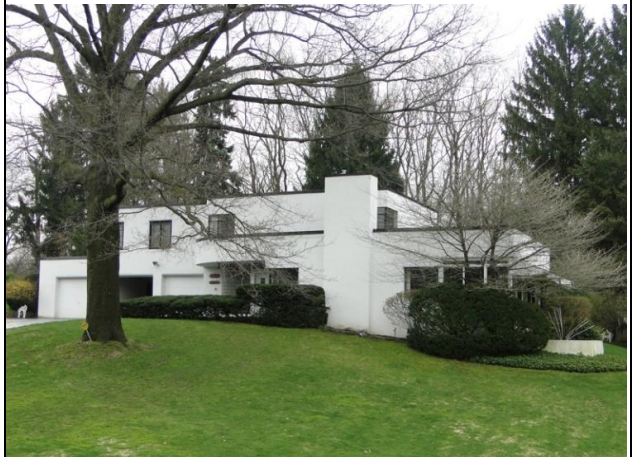
International

Design: Generally simple smooth exterior form and massing with little or no detailing or ornamentation, asymmetrical layout.

Materials: Smooth exterior surfaces, typically stucco, without ornamentation or detailing.

Roof: Flat roof without any edge detailing or coping.

Windows: Picture or gridded windows set almost flush with exterior wall. No trim. Ribbon windows or windows which wrap around corners often found.

Details: Very little ornamentation. Exterior areas which do not have windows are typically left as large blank areas of wall. Use of cantilevered overhangs common.

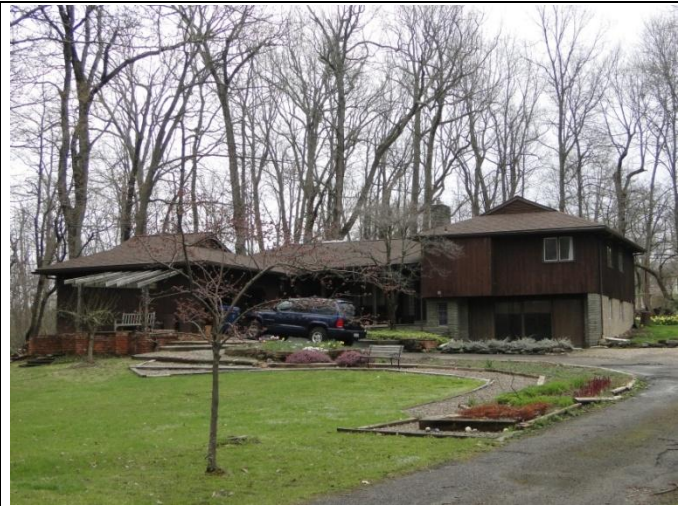
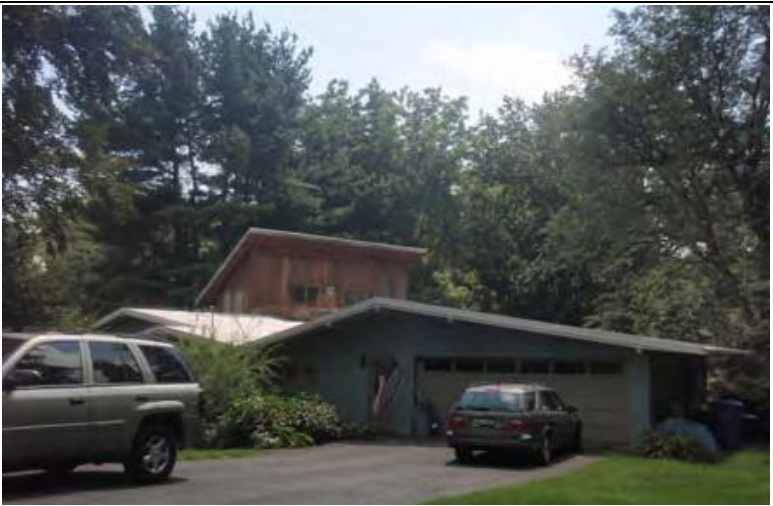
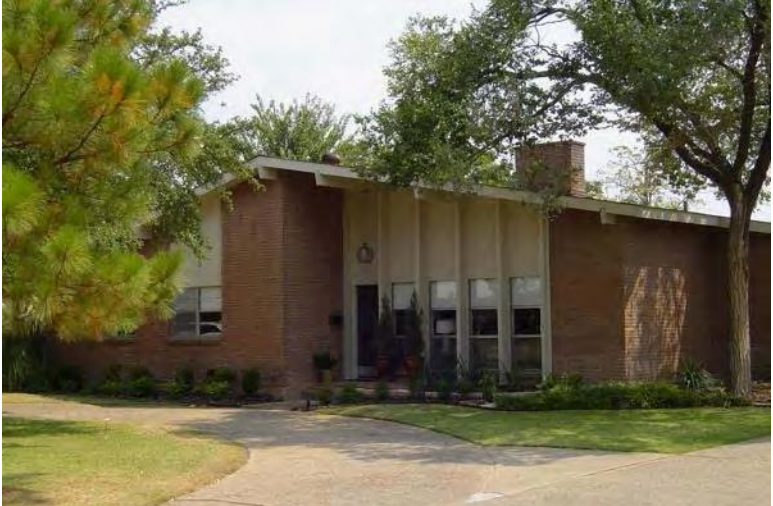
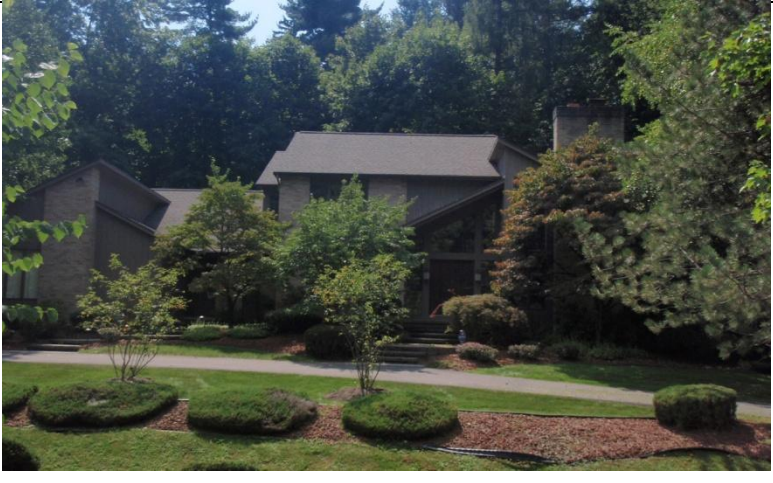
Contemporary

Design: Asymmetrical layout.

Materials: Typically vertical wood siding, stone or brick.

Roof: Low to moderate roof slope with overhanging eaves, often with exposed rafter tails. Asphalt shingles most common. Some flat roof examples.

Details: Exposed rafter tails or roof beams. Asymmetrical gable shapes, where one side of gable is cut short.
