RESIDENTIAL STYLES GUIDE

Dated: November 18, 2011

Adopted by Town Board: December 7, 2011

Residential Styles Guide

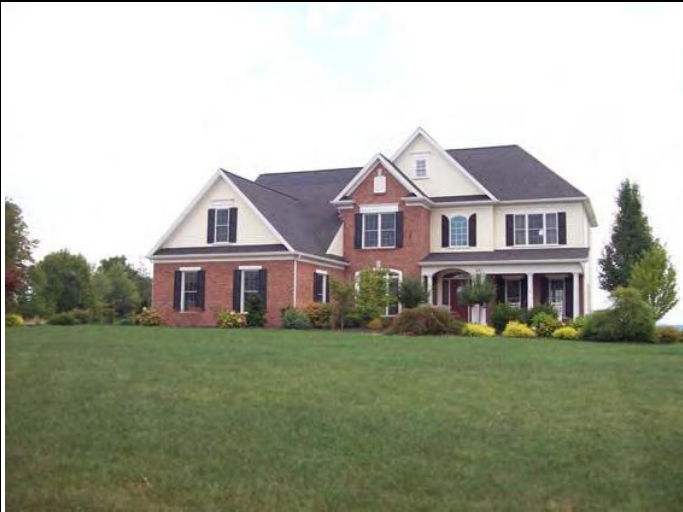
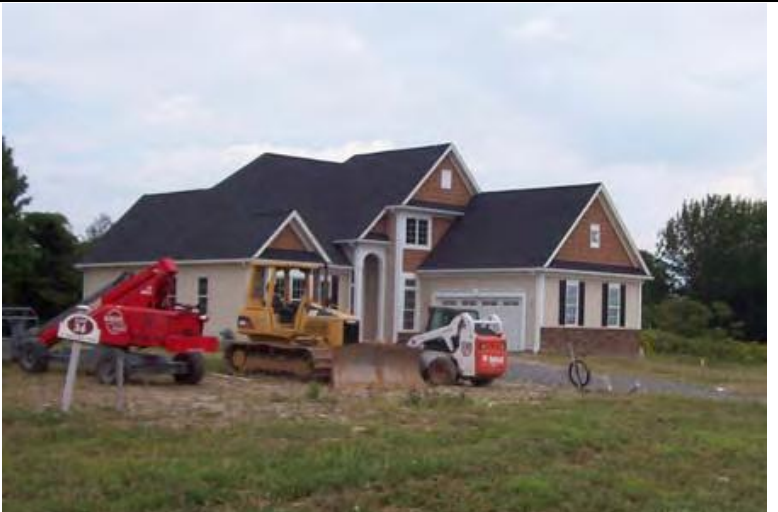
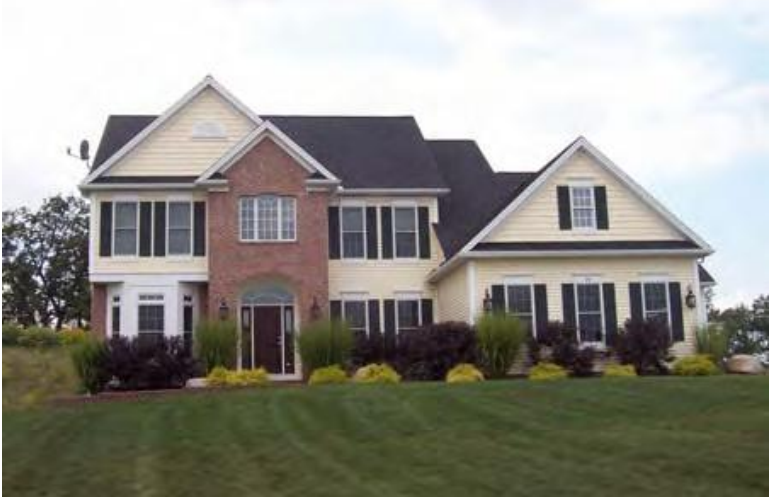
Neo-Traditional

Design: Asymmetrical layout with gabled roof and steep roof pitch, one or more cross gables. Generally imitates traditional styles such as Queen Anne. Attached garage.

Materials: Wood clapboard, often mixed with brick or sometimes stone. Asphalt shingles.

Roof: Steep roof pitch, often with complex forms, hip roof and smaller gables nested inside of larger gables.

Windows: Typically double-hung, simulated divided light, often with decorative (non-functional) shutters.

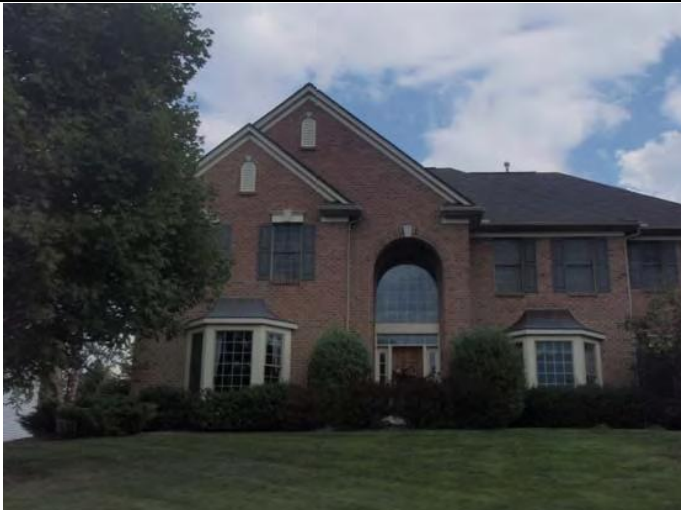
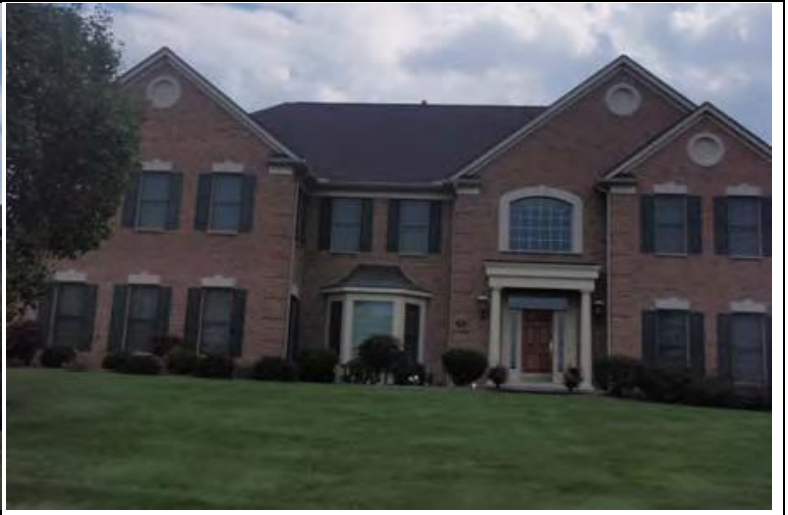
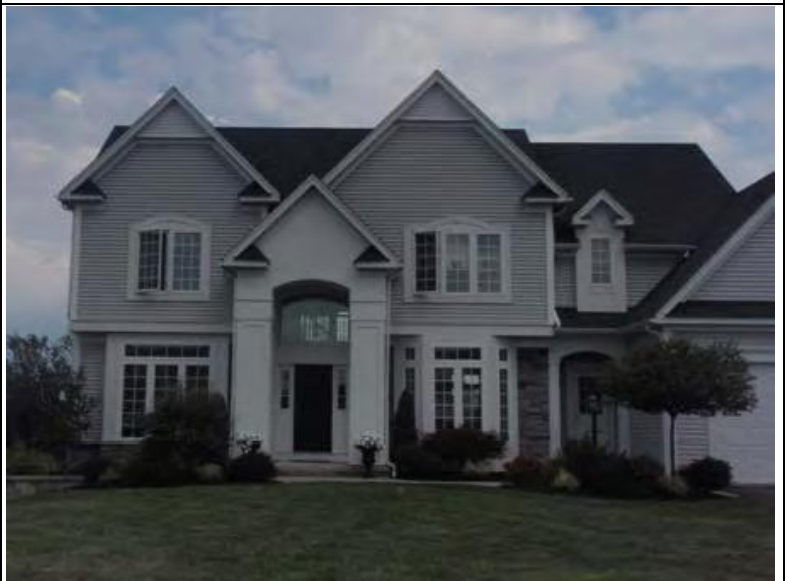
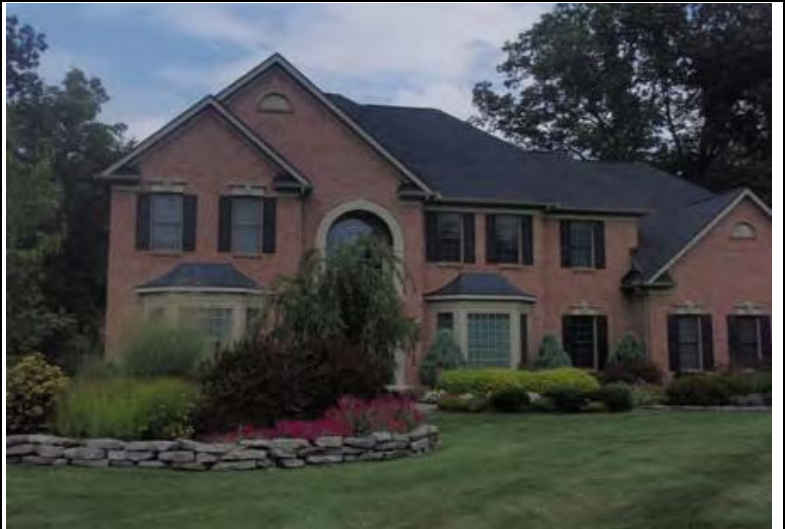
Neo-Eclectic

Design: Asymmetrical layout with prominent front facade, gabled roof and steep roof pitch, one or more cross gables. Attached garage.

Materials: Most commonly brick, with some wood clapboard, sometimes mixed with stone. Asphalt shingles most common.

Roof: Steep roof pitch, broken pediment gable. Roof often made of complex forms, hip roof and smaller gables nested inside of larger gables.

Details: Very prominent front entryway, often 2 stories in height highlighted with large windows above and/or flanked by large columns.
